# ***Hydraulic Cylinder Troubleshooting***

***Avoiding Rod Seal Leakage and  
Premature Wear***

*Bulletin 1242/1-GB*

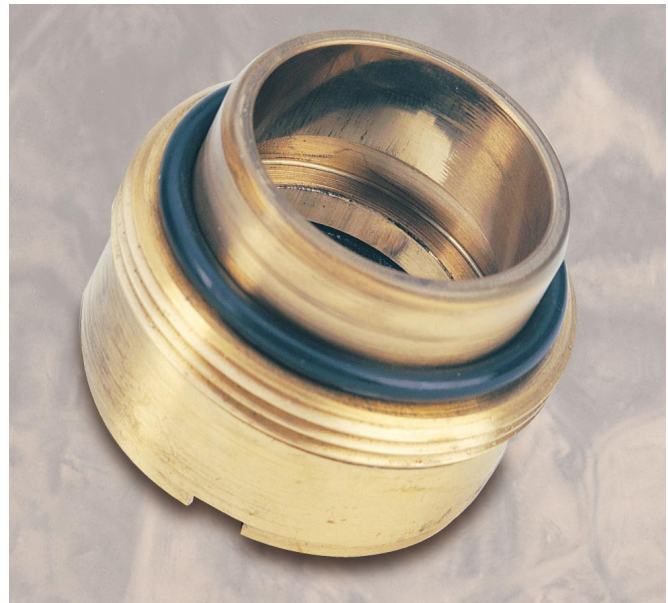
**SYMPTOMS:** Rod seals and bearings are worn on one side only (Fig. 1). Piston rods and cylinder tubes are worn or galled on opposite sides, particularly at or near full extension (Fig. 2). Piston rods should be straight within 0.15mm per metre; T.I.R. and surface finishes should be below 0.4 microns R.M.A.

**Fig.1 Gland and seal showing wear resulting from excessive side loading. Brass 'paste' on seal is a mixture of gland material and hydraulic fluid.**

**SOLUTION:** There is no substitute for precision in machine alignment. Alignment couplers, spherical bearings and floating flanged rod ends may help in some applications, but they

often require larger diameter piston rods or longer stop tube lengths to make up for the higher bearing stresses caused by the loss of rigidity between the piston rod and its moving load. Parker cylinders are available with substantial load bearing capabilities, and severe failures of components indicate the need for a thorough review of the application.

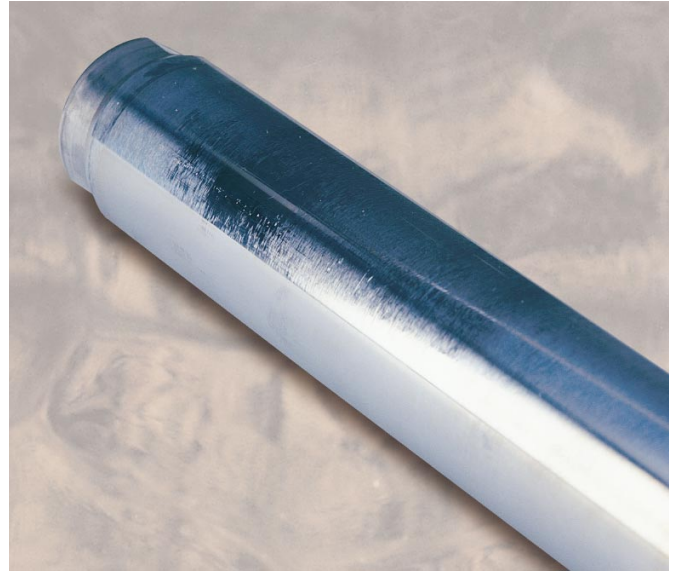
**Fig.2 Galling on this piston rod is evidence of excessive side loading.**

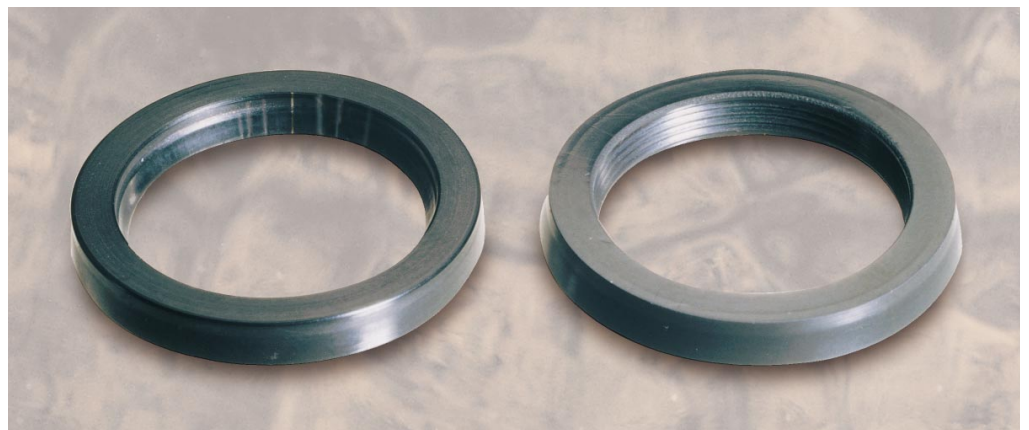
**Fig.3 Contamination damage is apparent in this rod seal, where the serrations are worn completely away. The seal on the right is a new one, shown for comparison.**

**SYMPTOMS:** Moderate to extreme leakage, with hydrostatic leakage. Particle contamination appears as score marks on the seal (Fig. 3) and rod bearing, and on the cushion sleeve (Fig. 4). Water in the oil may cause some seal materials to crumble or disintegrate at high temperatures (Fig. 7). Air bubble damage appears as small score marks on the inner surface of the high pressure side of the seal, and the heel of the seal may appear to be 'nibbled' (Fig. 5). The trumpet-shaped score is caused by expansion of the bubble as it works its way through the seal. Air bubbles may also attack the outer diameter lip of a rod seal, or may burn a hole through the heel of the seal.

**SOLUTION:** Particle contamination may be reduced through appropriate filtration methods, provided the fluid circulates from the cylinder to the reservoir in an efficient manner. To determine if a cylinder will efficiently flush oil and contaminants to the reservoir, compare the volume of oil contained in the cylinder to the volume of oil contained in the hose between the cylinder port and the directional control valve. If the hose holds more oil than the cylinder, particle contamination probably will not flow to the reservoir to be filtered out. Instead, it will remain in the cylinder and scour the seals. One solution is to relocate the directional valve closer to the cylinder to reduce the line volume to less than that of the cylinder. This allows oil to be flushed from the cylinder to the reservoir, to be filtered and cooled. Other solutions to particle and water contamination include the installation of metal rod scrapers or rod bellows to slow the ingress of contaminants. Paying close attention to the alignment of the cylinder on installation will also reduce the rate at which the cylinder produces its own fluid contaminants (Fig. 1).

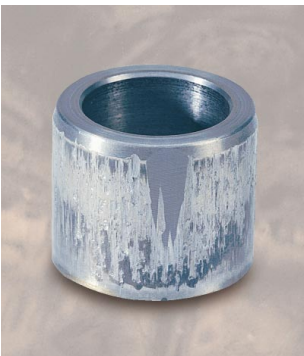
**Fig.4 Particle contamination has scored the surface of this cushion bush, resulting in loss of cushioning effect.**

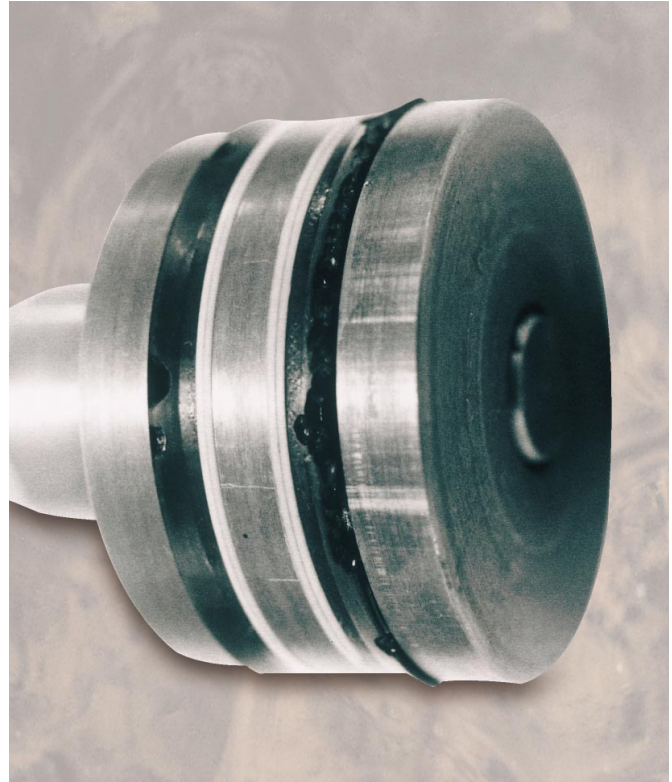
**Fig.5 Piston seals damaged by air in oil.**

All hydraulic oil contains dissolved air. Dissolved air cannot be bled out, and, in fact, does not cause a problem. The symptoms described above occur when air comes out of solution in the form of bubbles. Conditions that cause air to come out of solution are: rapid decompression, high flow through an undersized port (turbulent flow) or over-running loads. If a cylinder that was properly installed and bled continues to have problems with air, ie: if it seems to 'generate' air, it is likely that one of these three conditions is occurring. This is particularly true of applications involving water glycol fluids, since these are capable of dissolving more air than mineral oil fluids.

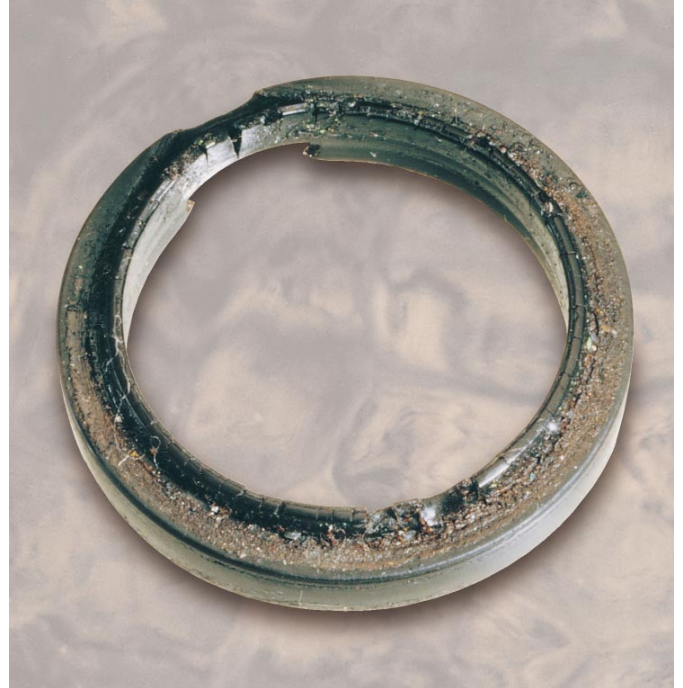
**SYMPTOMS:** Seals that have been overheated or exposed to too low a temperature have the same appearance: hard, cracked and brittle (Fig. 6).

*Fig.6 The cracked outer sealing lip of this wiper seal shows damage caused by heat.*

**SOLUTION:** Parker cylinders are available with high and low temperature seal options. In some applications, temperature control of the cylinders or oil must be provided to ensure effective operation.

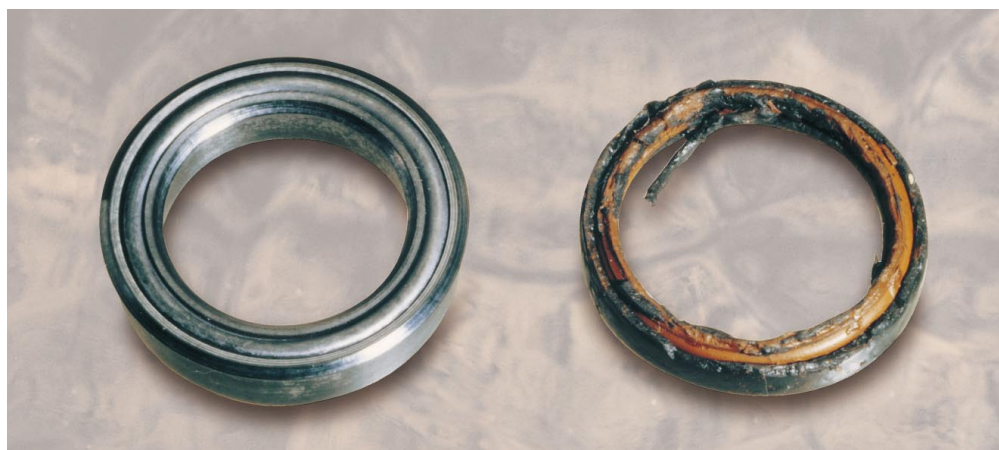
**SYMPTOMS:** Seals feel sticky or gummy in some cases, or may appear dry and cracked (Fig. 7). Shrunken seals may rattle in their cartridge grooves, while swollen seals may prove difficult to remove from the cylinder.

**Fig.7 Before and after. This polypak rod seal has been damaged by water, a common contaminant in mineral oil systems.**

**SOLUTION:** Ask your Parker representative for his recommendations for a particular fluid. He will consult with the fluid manufacturer and seal supplier to resolve the problem. Often, a simple test can be performed to determine the effects of a particular fluid/seal combination.

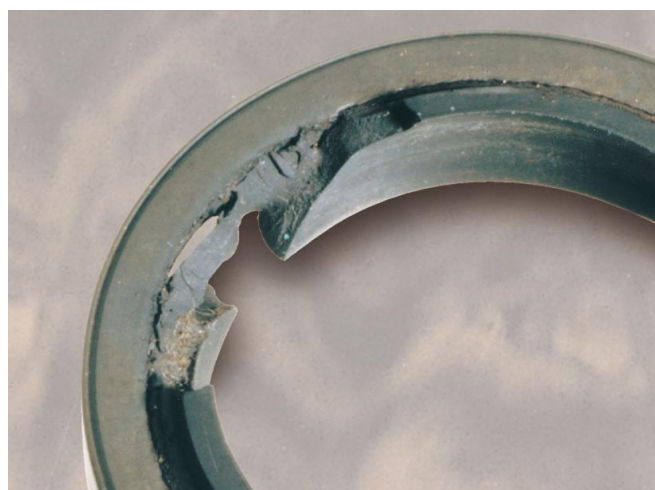
**SYMPTOMS:** Extreme amounts of leakage occur. Rod seals may be worn uniformly around their entire inner sealing surface. Extrusion damage manifests itself as 'flash' or feathered edges at the inner diameter of the heel of the seal (Fig. 8). Mechanical failure of seal support lands in rod cartridges or of cartridge retainer bolts can also occur.

**Fig.8 Wiper seal showing high pressure extrusion damage.**

**SOLUTION:** If excessive pressure is caused by intensification due to a flow restriction, the restriction should be removed. If the condition persists, a special gland and seal design should be

considered to reduce the extrusion gap, permitting the seal to withstand the high pressures.

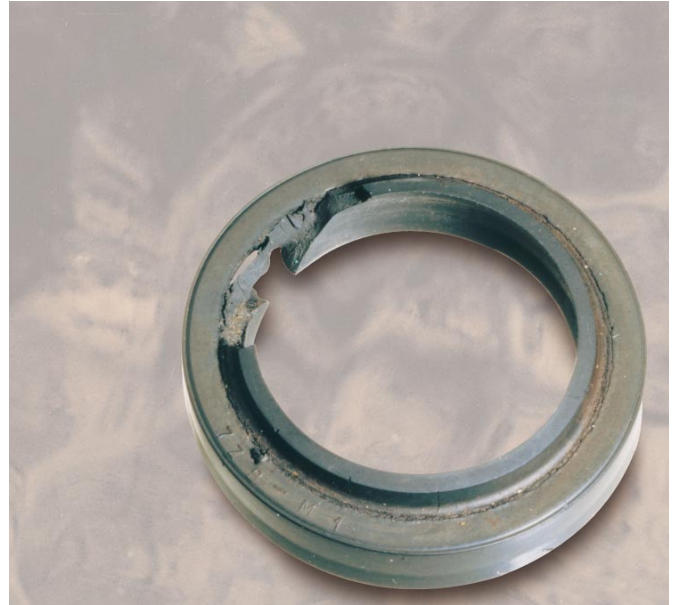
**SYMPTOMS:** The rod runs 'wet', with a collar of oil. The rod wiper may extrude, (Fig. 9) but the primary rod seal is undamaged (Fig. 9, inset) so that no leakage occurs when the cylinder is hydrostatically tested. This condition should not be confused with the 'running in' period required by some low friction seals, which may not give full dry rod performance until around 100 cycles have been completed.

**Fig.9** The rod wiper may extrude (top) but the primary rod seal looks perfect (right), so no leakage occurs when the cylinder is hydrostatically tested.

**SOLUTION:** Raise the back pressure to above 30 bar, or substitute a rod seal with better low pressure sealing characteristics. Note that some 'loaded' seals may exhibit excessive friction levels or may otherwise disrupt the normal operation of a primary and secondary sealing system.
